SUBJECT: 2014 + GM Intermittent Cluster, Radio and HVAC Display Resets

The following is Service Bulletin SV123 Rev 1 from BOSS Snowplow Technical Support. This bulletin was revised as of 2/11/2019.

Subject:Intermittent Cluster, Radio and HVAC
Display Resets on Snow Plow TrucksModels/Years
Affected:2014 Chevrolet Silverado 1500
2015 and beyond Chevrolet Silverado
2014 GMC Sierra 1500
2015 and beyond GMC Sierra
With Snow Plow Prep Package (RPO
VYU)Origination
Date:November 30, 2015
January 31, 2019

Bulletin #124j

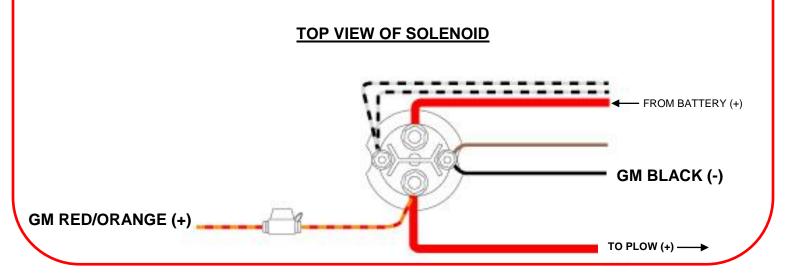
On page 3, paragraph b) of GM UI Bulletin #124J, it instructs the installer to: "Using a test lamp, try various connection points on the plow control wiring to identify a signal that will illuminate the test lamp only when the motor is running.".

This step is <u>NOT</u> necessary when using a BOSS 13-pin truckside harness. Instead, connect these wires to the BOSS solenoid per the image below:

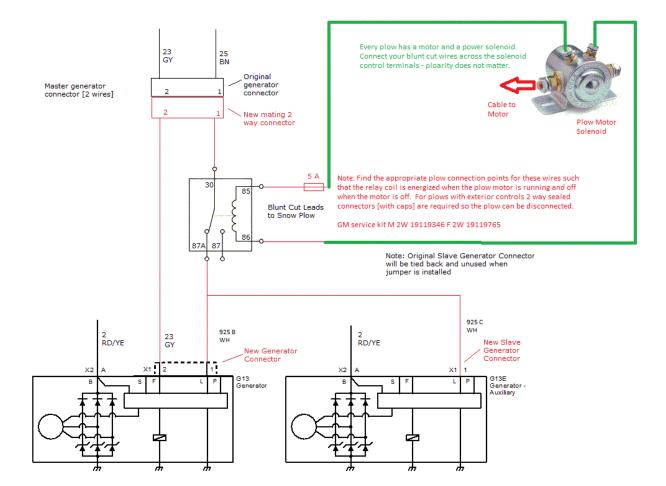
Fig 1: Jumper harness wiring schematic

VYU Service Harness for both single and dual generator trucks

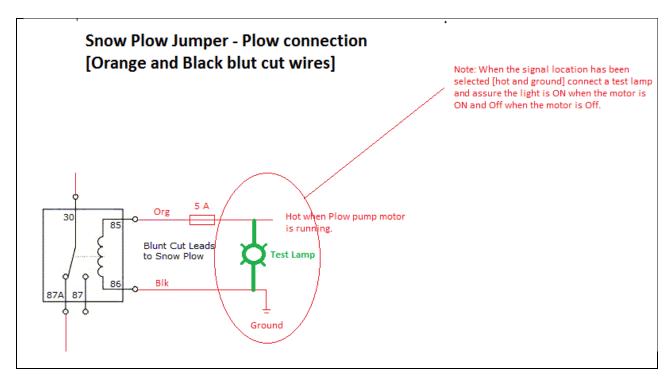
Note: To identify the signal needed by the jumper harness perform the following test. Any connection point that passes this test can be used. The best case is a signal from the wiring that remains with the truck but if that is not found then the signal must be found out on the plow itself.

- a) An operating signal must be identified to operate the small relay in the jumper harness. This signal should go ON and OFF with the plow pump motor. The relay requires low power < 1 amp so most any signal will do without loading issues. The schematic shows the control terminals on the motor solenoid which is the most common connection point.
- b) Using a test lamp try various connection points on the plow control wiring to identify a signal that will illuminate the test lamp only when the motor is running.
 Note:

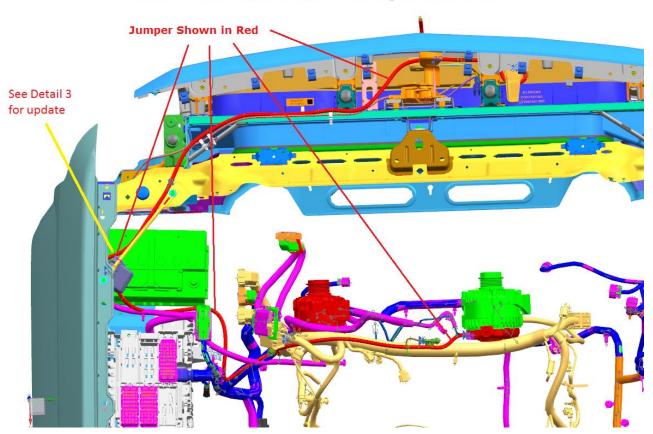
Fig: 3b Jumper Harness Layout – dual alternator [see detail 3 for updated relay mounting]

VYU Dual Alternator - Jumper Harness

- a) Unplug the control connectors on both alternators.
- b) Identify the master alternator connector [at the very tip of the harness when it is fully extended]. Insert it in the 'master' alternator on the RH side of the engine.
- c) Identify the 'slave' alternator connector on the jumper harness and insert it in the LH 'slave' alternator. Insert the removed LH alternator connector into the [unwired] cap on the jumper harness.

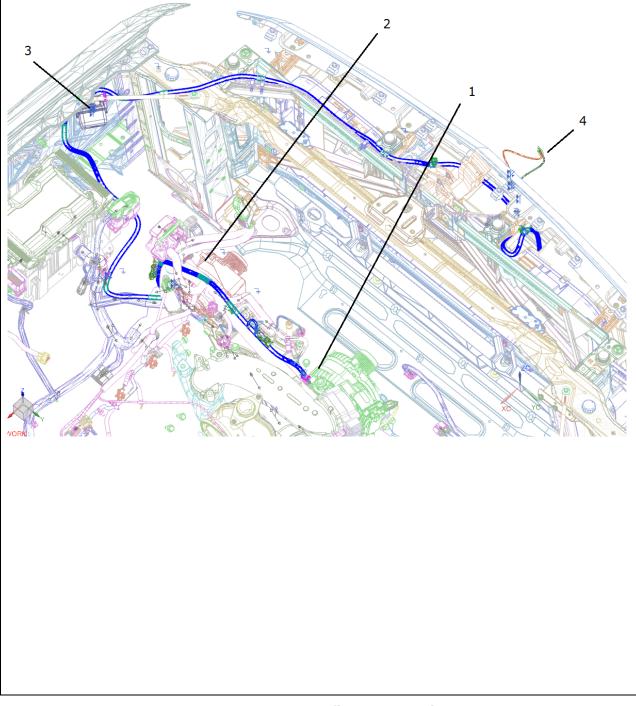
Layout Details

- 1. Primary Alternator
- 2. Slave Alternator
- 3. Relay Center and [new] corner brace
- 4. Wires to plow [fused + & ground]

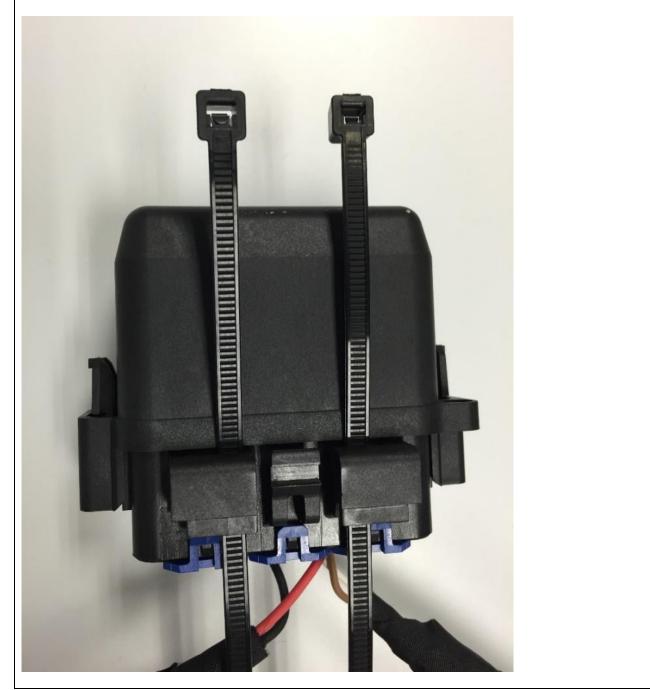
Detail 3.1.1

Details 3.1.1-3 apply to service part and not the factory included [loose shipped] part.

- Route the snow plow jumper harness along the existing harness routing where possible and secure the relay center with tie straps as shown in Details 3.1.1-3. Allow slack for engine roll and upright orientation of the relay center to prevent water intrusion/collection.

Add tie straps to relay

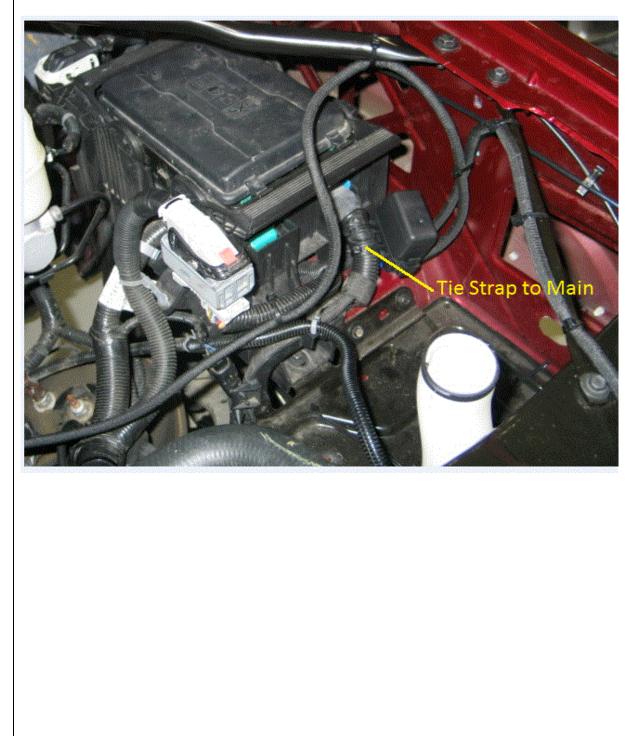
Detail 3.1.2

Single Battery Trucks

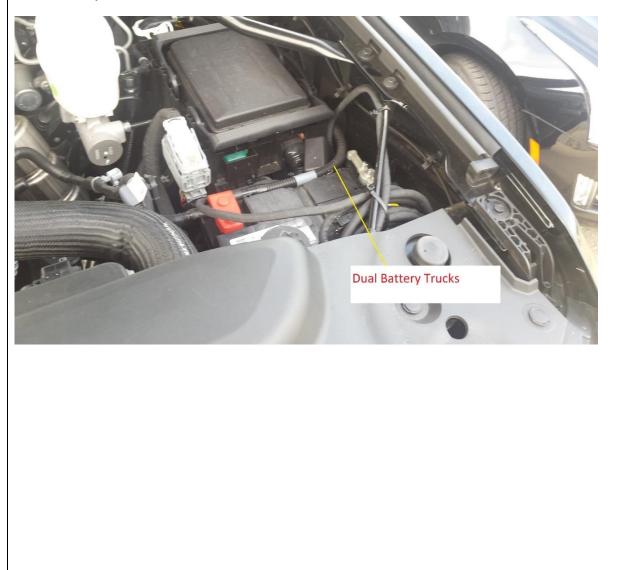
Detail 3.1.3

Dual Battery Trucks

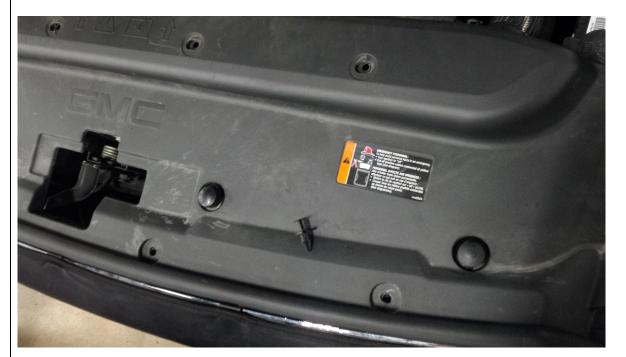
Detail 3.2.1

The following details 3.2.1 – 7 apply only to trucks that came with harness components [loose shipped] from the assembly plant.

Remove the Radiator Air Upper Baffle and Deflector.

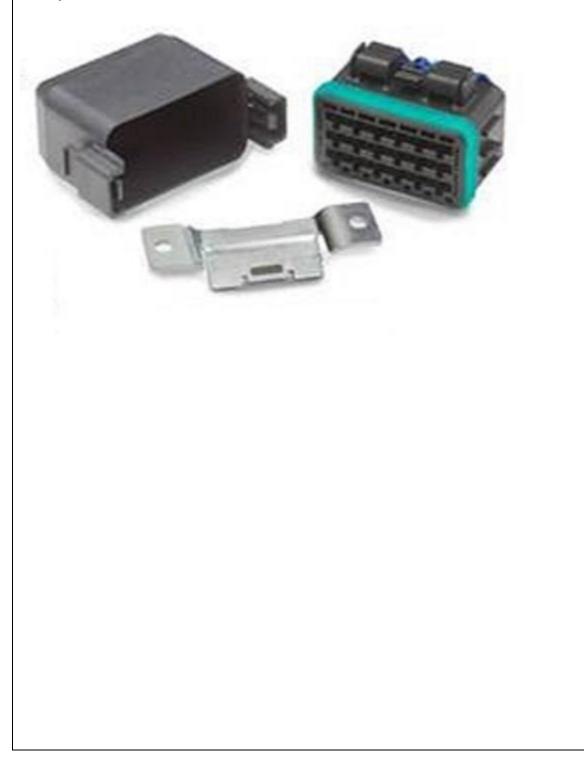
Detail 3.2.3

Relay center and bracket details.
